# Insulating a solid-brick wall in a Victorian house

## Background

The property is an end-of-terrace Victorian house, extended and upgraded about 15-20 years ago. The house is a letting property and since all landlords must now produce an EPC to give to the new tenant, an energy audit was carried out and report prepared.

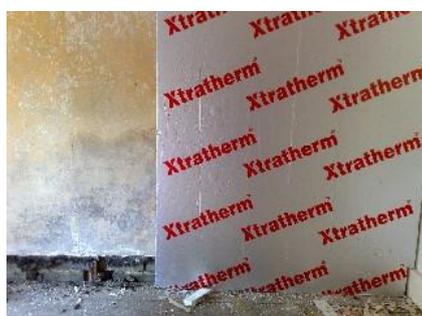
The inspection showed that the main roof insulation was below the current recommended level of 270mm and that the flank wall of the rear bedroom was only a half-brick (115mm) thick. The bedroom was very cold. The EPC calculated was 59, which is in band D for Energy Efficiency Rating and also band D for the Environmental (CO<sup>2</sup>) Impact Rating.

In order to improve the conditions in the bedroom and the Energy Efficiency for the house as a whole, top-up fibreglass insulation was added to the roof void. The flank wall was lined with PIR (Polyisocyanurate rigid) insulation, which was then battened and covered by plasterboard. This resulted in an increased U-value for the wall of 0.25 W/m<sup>2</sup>K.
