Rotafix Resin Timber Repair – Case Study

This case study outlines the products and methods used to repair a floor/ceiling joist using carbon fibre and Rotafix Structural Adhesive (RSA). The client requested to develop a repair methodology for a jettied 16th century property located in St Albans, Hertfordshire. The building has been extensively reworked throughout the centuries with many later phases of alteration.

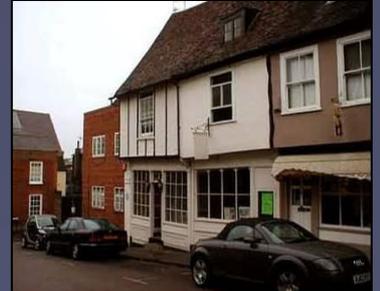
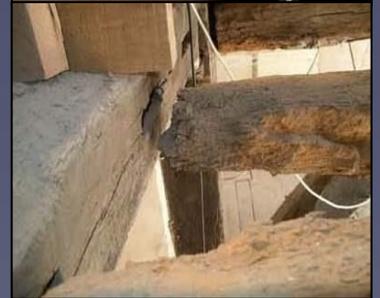
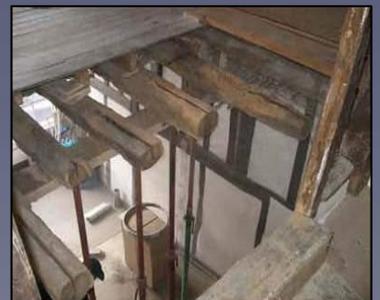
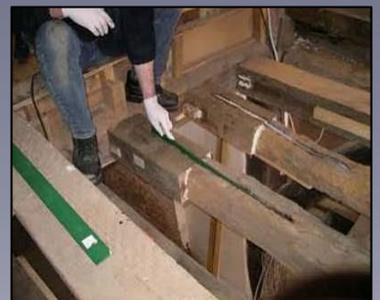
The carbon fibre strip was then cut to length to match the length of the slot. The pictures show the carbon fibre strip in its protective green coating which was subsequently removed.

The damaged timber on each of the floor joists was removed. The length of damaged timber removed from each floor joist varied. Each joist was slotted prior to having the end carefully removed. New joists were prepared in species matched oak with a similar moisture content.

The slots in the existing timbers were aligned to the new timber ends then cut ensuring exact positioning and depth of the slots. Once the slots had been cut and thoroughly cleaned RSA was injected through a tube into the base of the slots.

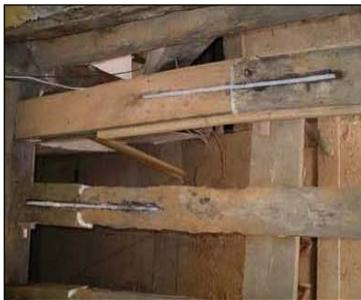
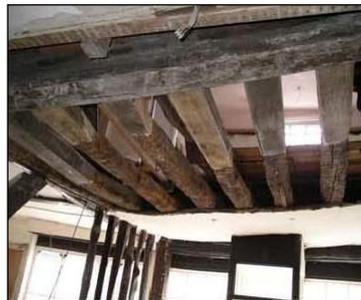
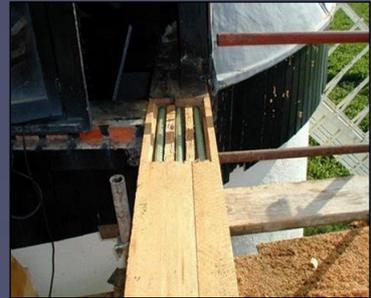
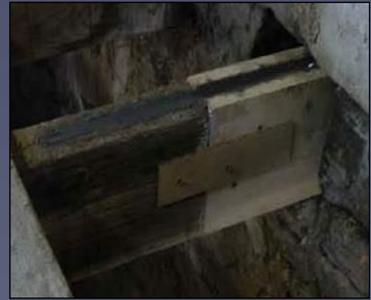
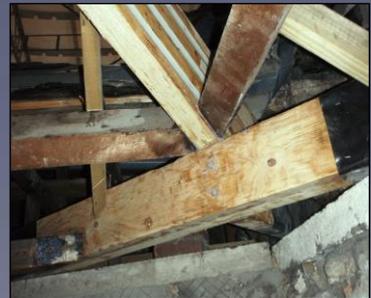
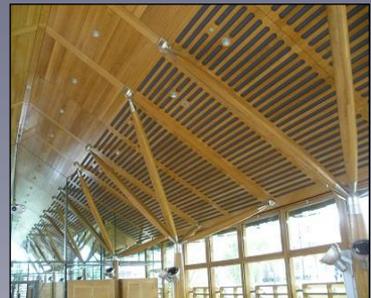
The carbon plate was inserted centrally into the previously injected RSA and then the slot was filled with a further layer of RSA as shown below. The props supporting the repair remained in place for 7 days. The new timber was contoured to match the distressed look of the original timbers.

As the flooring covered the repair there was no cosmetic or aesthetic requirement to hide the adhesive. When there is an aesthetic requirement a thin slip of matching wood can be inserted to give a colour match and to cover the repair.
