Waterproofing a basement flat

Anglia Property Preservation Limited

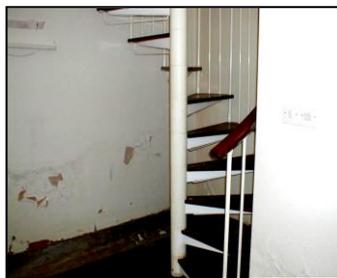
This house is a Large Victorian property converted into flats. The basement of this flat was used as the bedroom. After heavy rainfall the basement flooded due to the failure of the existing waterproofing system. Water pooled to a depth of 5cm throughout the basement area. The tenant had to vacate the property whilst the landlord allowed the area to dry out and subsequently improve the living condition of the bedroom.

Water pooling after heavy rain

In order to improve the conditions in the basement (Classed as a Grade 3 area by the *Code of Practice for Protection of Structures against Water from the Ground (BS8102)*) it was necessary to install an effective waterproofing system. A Delta Cavity Drain Membrane System was used.

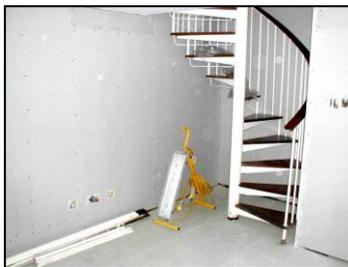
White Delta membrane applied to walls

Floor and wall surfaces were prepared including the removal of electrical fittings. A sump pump was supplied and fitted. The sump collects the moisture that has drained via the cavity. When the water reaches a predetermined level the pump is triggered and the water is removed. An alarm that sounds in the event of an excessively high water level was fitted to the sump. To prevent flooding to the completed conversion in the event of a power failure, a battery backup unit was supplied and fitted.

Delta cavity drain membrane was supplied and fixed to the walls and floors by qualified installers. Battens and plasterboard were then fixed to provide a surface for the applications of a smooth skim plaster finish. A new chipboard floor was laid. Electrical fittings were then reinstated and the property was left ready for redecoration

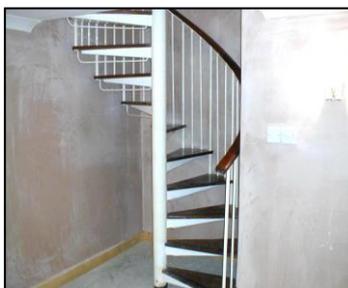
Ready for redecoration
